INDOOR AIR QUALITY ASSESSMENT

**Raynham Town Hall
558 S. Main St, Raynham, MA**

Prepared by:
Massachusetts Department of Public Health
Bureau of Environmental Health
Indoor Air Quality Program
September 2018

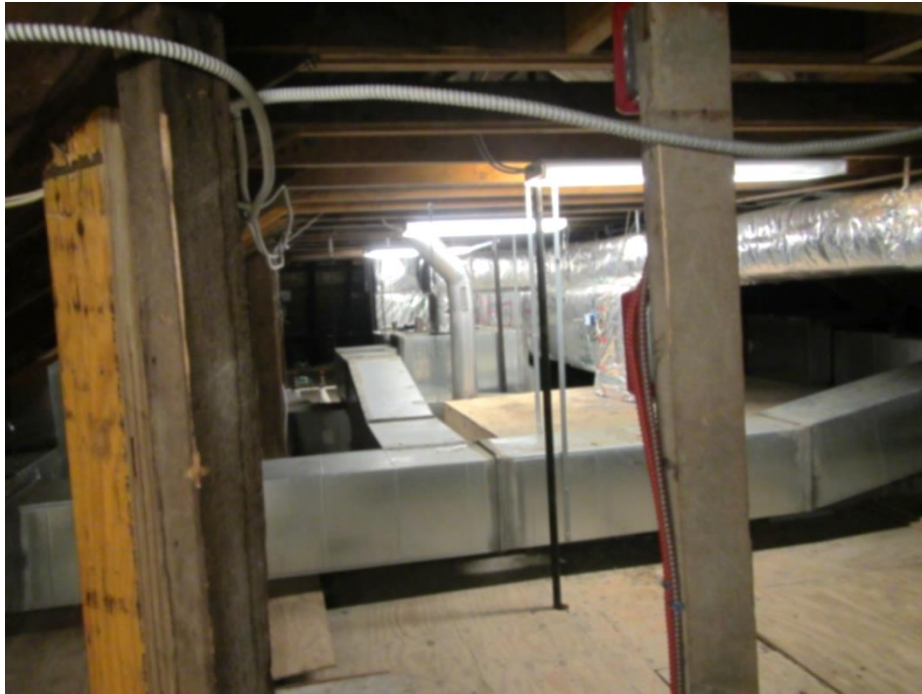
Picture 1

It can be seen from Table 1 that carbon dioxide levels were below 800 ppm in all areas surveyed. A heating, ventilation, and air-conditioning (HVAC) system was retrofitted into the attic space of the school when the building was renovated in 2007. Air-handling units (AHU) are located in the attic (Picture 1), while condensers are located on the building exterior (Picture 2). Filtered air is supplied to occupant areas via ceiling-mounted diffusers (Picture 3); air is brought back to the AHUs via ceiling-mounted return vents (Picture 4). BEH/IAQ Program staff could not identify a fresh air source to the AHUs. If the AHUs do not have a fresh air source, they will recirculate air within the building. Without a fresh air source, normally occurring indoor air pollutants tend to accumulate.

Air-handling units and ductwork in the attic

1. Operate the HVAC system during all occupied hours. During hot weather, periodically check the HVAC unit to ensure continued delivery of conditioned air.

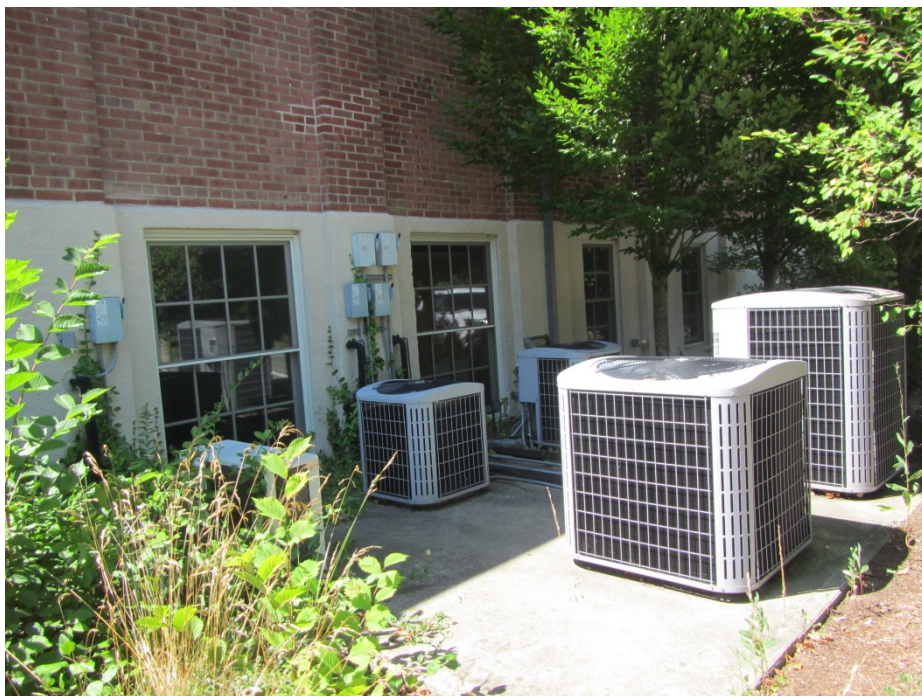
Picture 2

Plants were also noted growing close to the foundation (Pictures 2 and 9) which can hold water against the bricks and lead to deterioration. Roots growing into the foundation can also damage building materials and lead to increased chances of water penetration. In addition, leaves

Air conditioning condensers on the outside of the building, also note trees close to building

10. Trim plants and trees away from the building to prevent damage to the foundation and potential water infiltration. Trim trees from overhanging the roof.

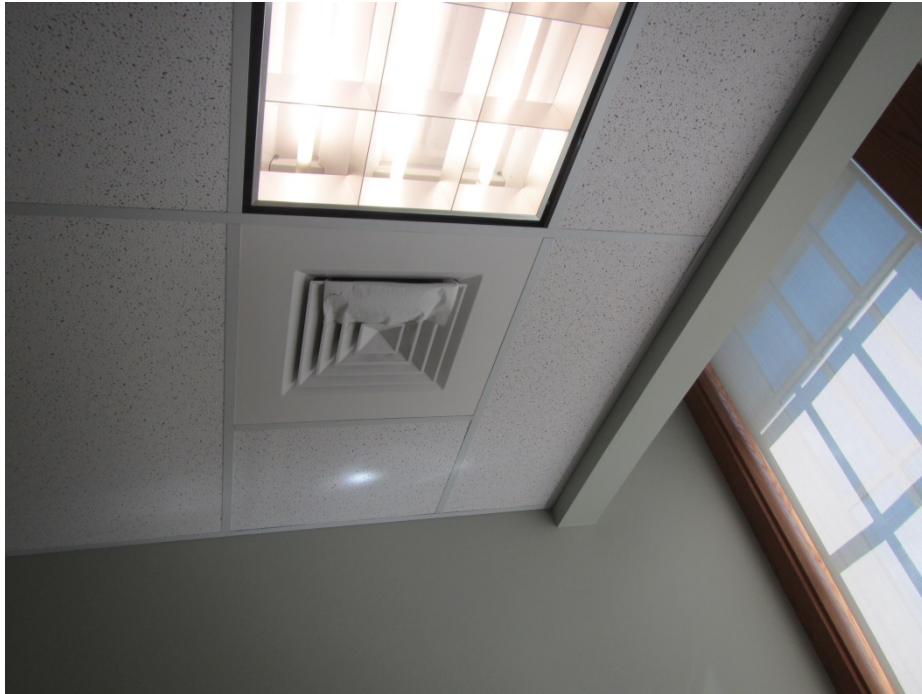
Picture 3

Typical supply vent

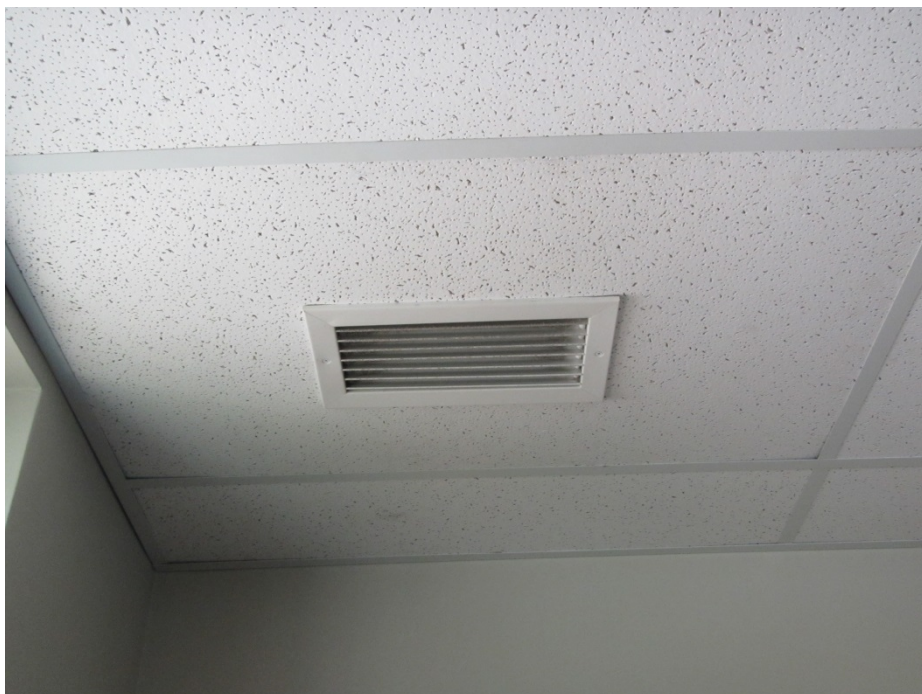
Picture 4

Return vent

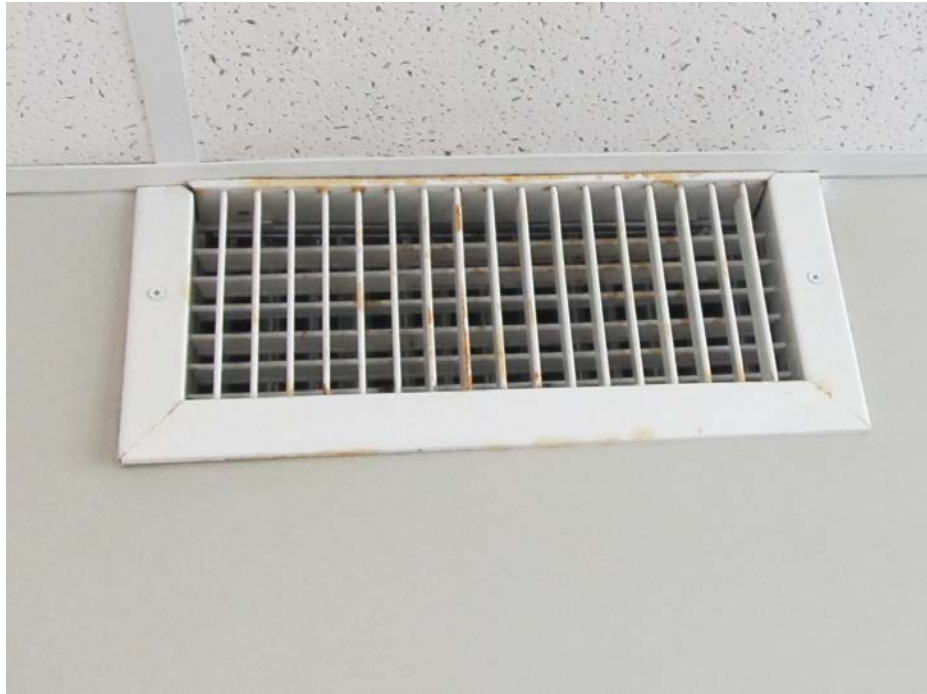
Picture 5

BEH/IAQ Program staff noted rust stains on air diffusers on the ground floor of the building (Picture 5). These stains suggest water is condensing on the metal diffusers when the air conditioning is in use. Condensation occurs when humid air comes in contact with a surface that is lower than the dew point, which can occur when the air conditioning system chills the supply diffusers which are in contact with humid basement air. In some basement offices, paper items hanging on walls had curling edges (Table 1), further indicating high humidity in these areas. Below-grade spaces are more likely to experience elevated relative humidity levels. Relative humidity in excess of 70 percent for extended periods of time, even in the absence of other sources of water, can provide an environment for mold and fungal growth (ASHRAE, 1989).

Rust stains on ground floor supply vent indicating chronic moisture

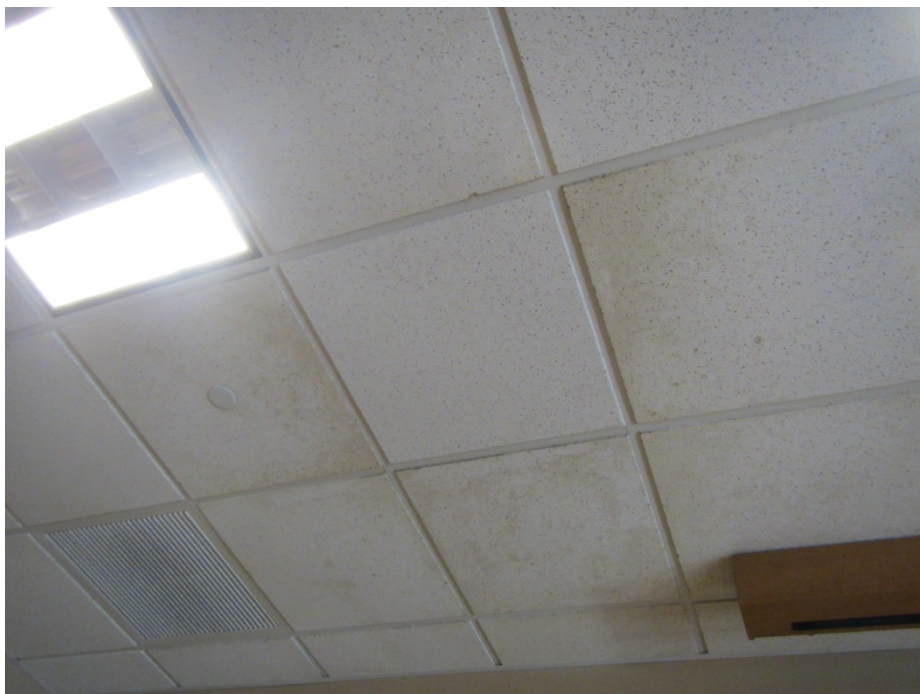
Picture 6

Water-damaged ceiling tiles were observed throughout the McKinnon meeting room (Picture 6). Plumbing leaks are likely the source of this water damage. Leaks should be repaired, and water-damaged ceiling tiles should be replaced once the leaks have been fixed. During the replacement, the area above the ceiling tile system should be checked for any additional water damage or odors and cleaned or repaired as needed.

Water-damaged ceiling tiles

6. Avoid storing any porous materials on the floor on the lower level to prevent water damage.
7. Repair roof or plumbing leaks that are leading to water-damaged ceiling tiles. Then replace stained tiles after inspecting above the ceiling tile system, and cleaning as necessary.

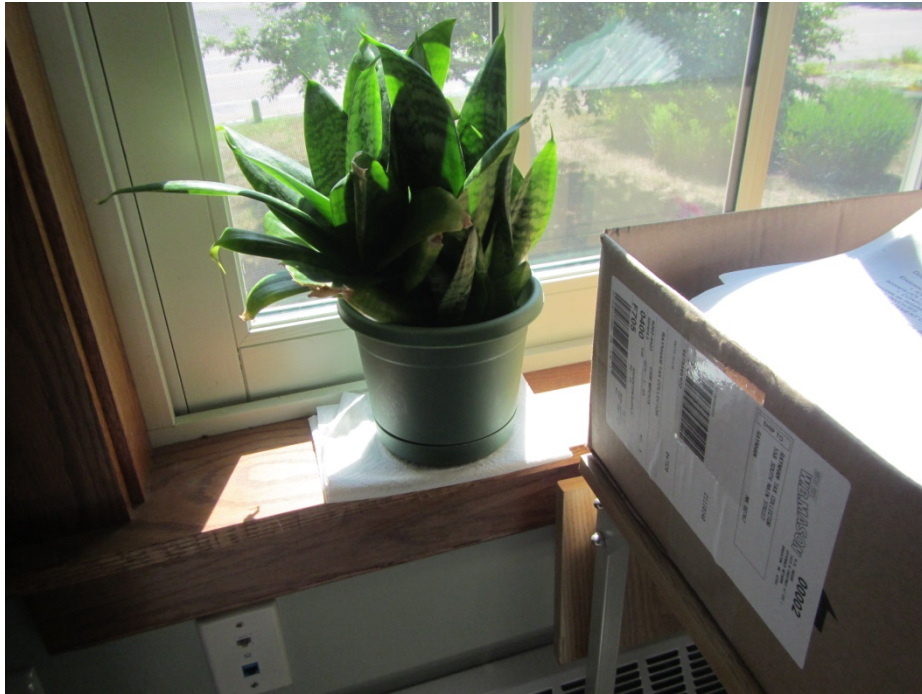
Picture 7

Indoor plants were observed in a few areas (Picture 7; Table 1). Plants can be a source of pollen and mold, which can be respiratory irritants to some individuals. Plants should be properly maintained and equipped with drip pans and should be located away from air diffusers to prevent the aerosolization of dirt, pollen and mold. Plants should not be placed on porous materials such as paper towels or cloth, as these items are likely to become moistened and lead to microbial growth.

Plant on porous material

8. Ensure indoor plants are properly maintained and not overwatered, and ensure each has a waterproof drip pan to prevent damage to porous materials.
9. Repair sink backsplashes with appropriate caulking material, or replace with a single-piece unit.

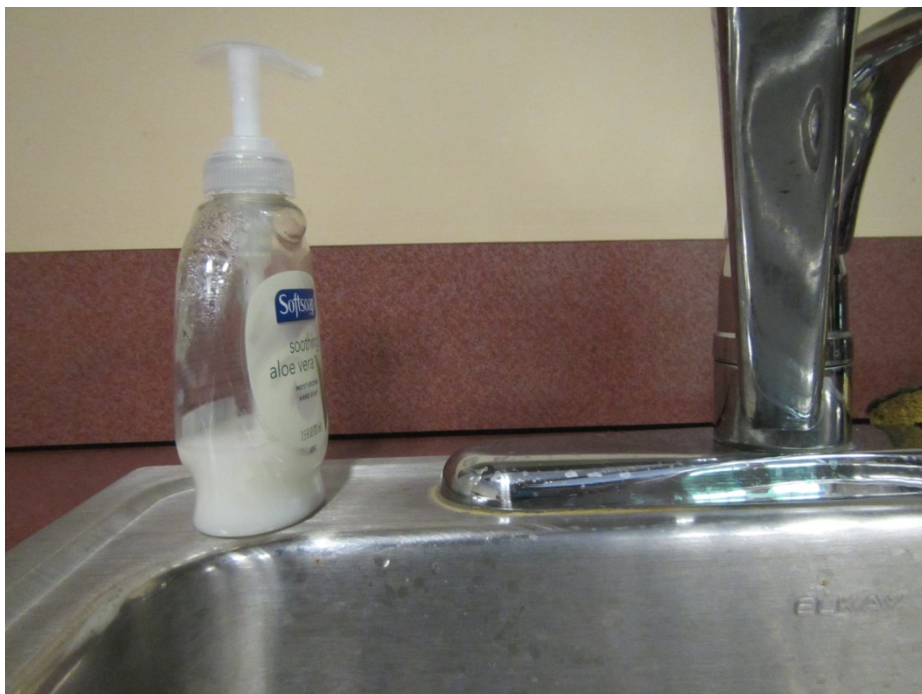
Picture 8

Several sinks in the building had gaps between the countertop and the backsplash (Picture 8). This gap can allow moisture to penetrate into the wood and lead to deterioration or mold growth. Sink backlashes should be sealed with caulking or replaced with a single-piece backsplash unit with no gap.

Gap in sink backsplash

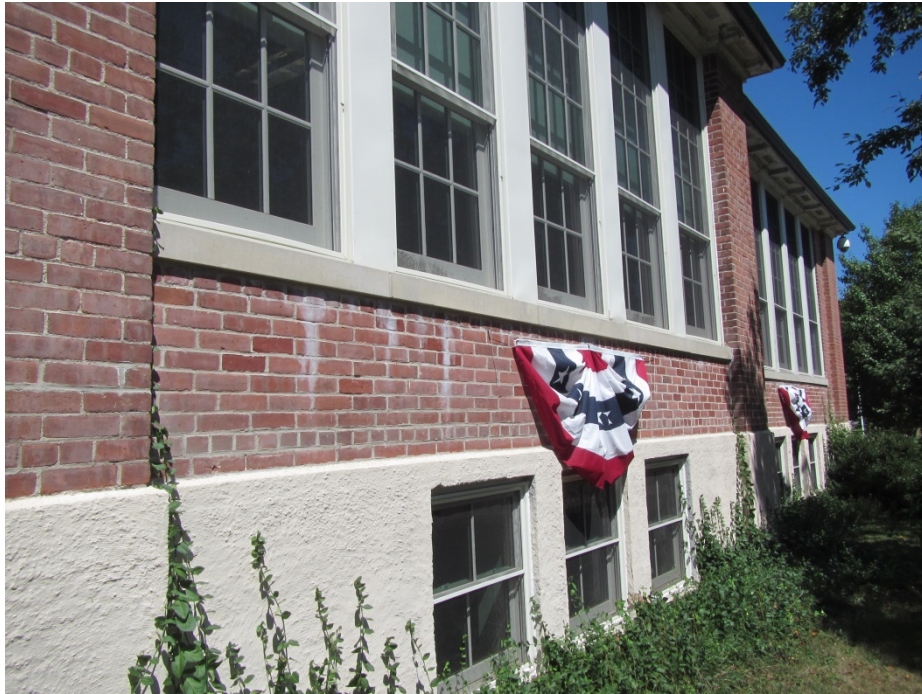
Picture 9

from overhanging trees can clog drainage gutters and downspouts on the roof. Plants should be trimmed away from the side of the building.

Plants against foundation

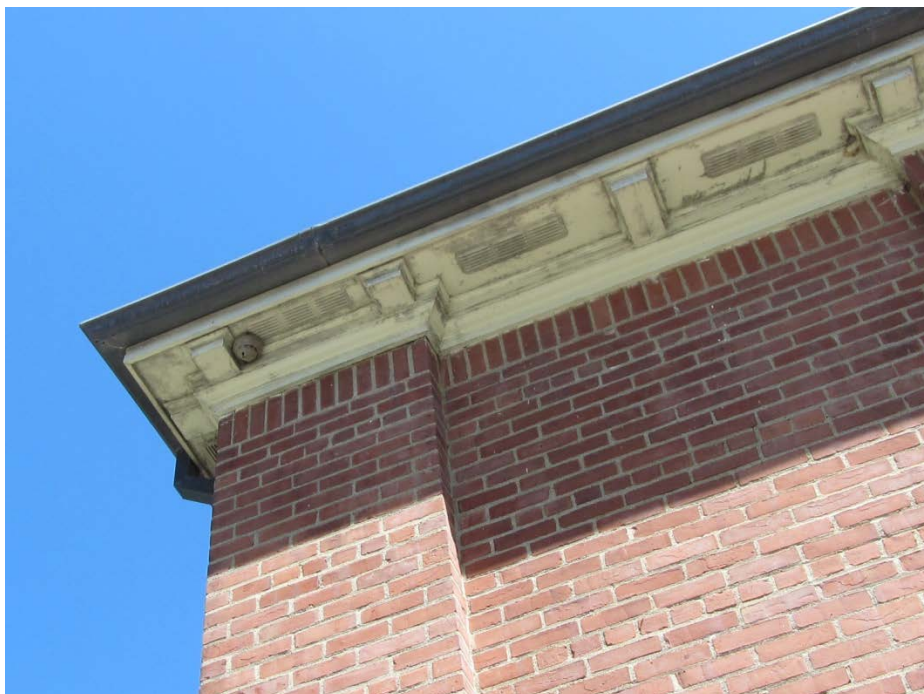
Picture 10

An insect nest was observed hanging from the outside of the building in a back corner (Picture 10). A licensed pest contractor should be engaged to assist with identification and removal of the nest to prevent deterioration of the building as well as potential stings.

Insect nest under eaves of building

14. Consult with a licensed pest contractor to identify and safely remove the insect nest from the eaves of the building.
15. Refer to resource manual and other related indoor air quality documents located on the MDPH's website for further building-wide evaluations and advice on maintaining public buildings. These documents are available at <http://mass.gov/dph/iaq>.
